SECTION 8

OV-102 (STS-87) TPS Damage

Date: April 2, 1998
No.: 270-200-98-017
To: J. T. Hughes
RSS - Downey
D/270-200, 841-AC85
From: M. L. Helsel, V. H. Bui
RSS - Downey
D/270-200, 841-AC85
Subject: **TPS Damage Assessment of STS-87 and STS-89**

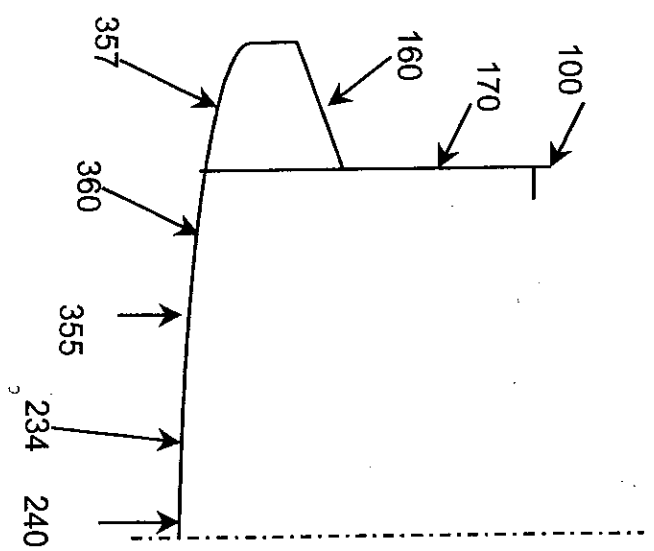
- Simulation with Damage More Severe than STS-87 Significantly Degraded Safety Margins
- 25% Decrease in Tile Thickness in Out Board Panels Gives Large Increase in In-Plane Gradients and Thermal Stresses
- Cannot Achieve Required 1.40 Factor of Safety - Approximate Contingency Capability Is:
 - TAEM - F.S. = 1.0 at 1.8 g's
 - Land - F.S. = 1.2 at 5.5 feet/sec
 - = 1.4 at 3.0 feet/sec

CONCLUDE - With Hypothesized Damage (Second Scenario), Factor of Safety Will Be Less Than 1.0

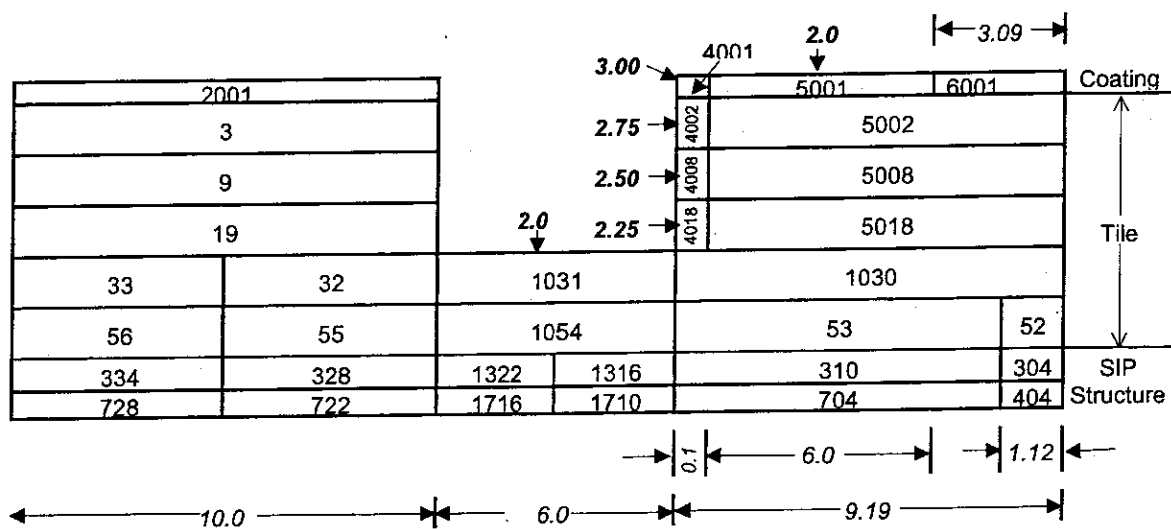
Figure3 - Cross Section Nodal Diagram of TMM 99
(Heating Bump Factors in Bold Face Type)

To simulate the increased local heating due to the presence of the cavity, bump factors, provided by aeroheating, were imposed on the heating in and around the hole. Figure 3 shows the heating factors and where they were applied. The emissivity of the damaged tile surfaces was reduced to 0.5 due to the lack of black coating. Bottom sun entry interface (EI) temperatures were used for a worst case analysis.

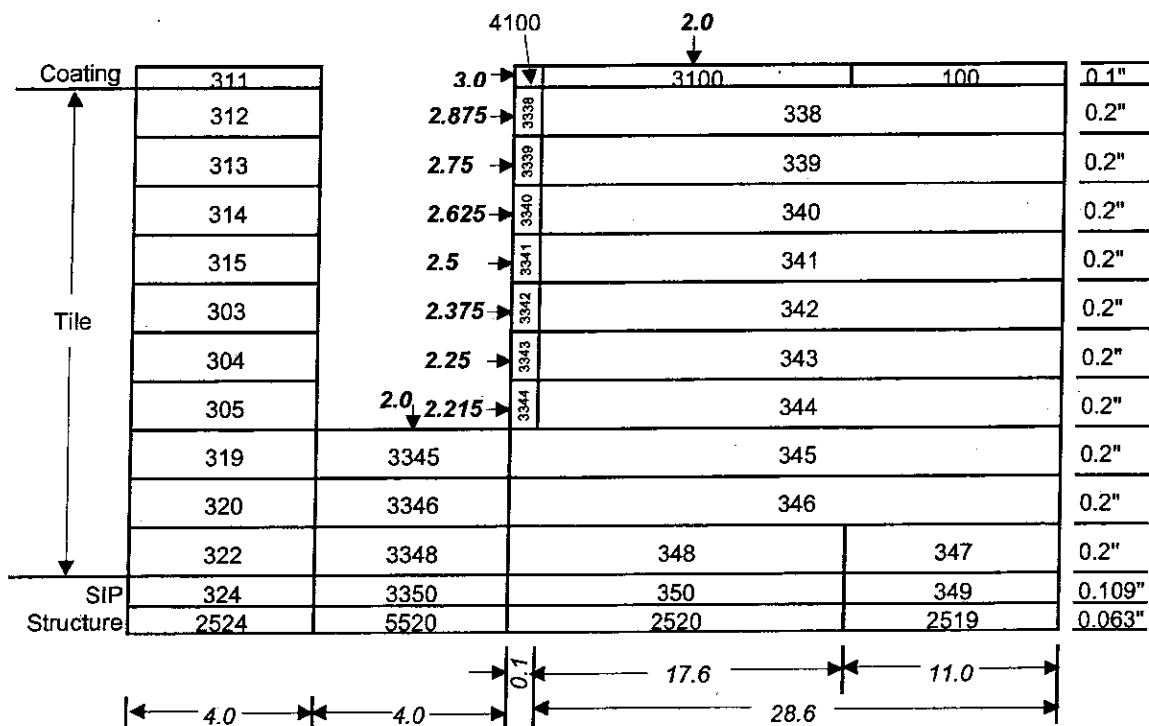
Figure 5 - Cross Section Nodal Diagram of Hole Location 1 of TMM 352
(Heating Bump Factors in Bold Face Type)

The model was renodalized in a similar manner to the TMM 99 modification. Heating bump factors were generated for this configuration as shown in Figure 5. The 0.5 emissivity for broken tile and the bottom sun EI temperatures were also used for this analysis.

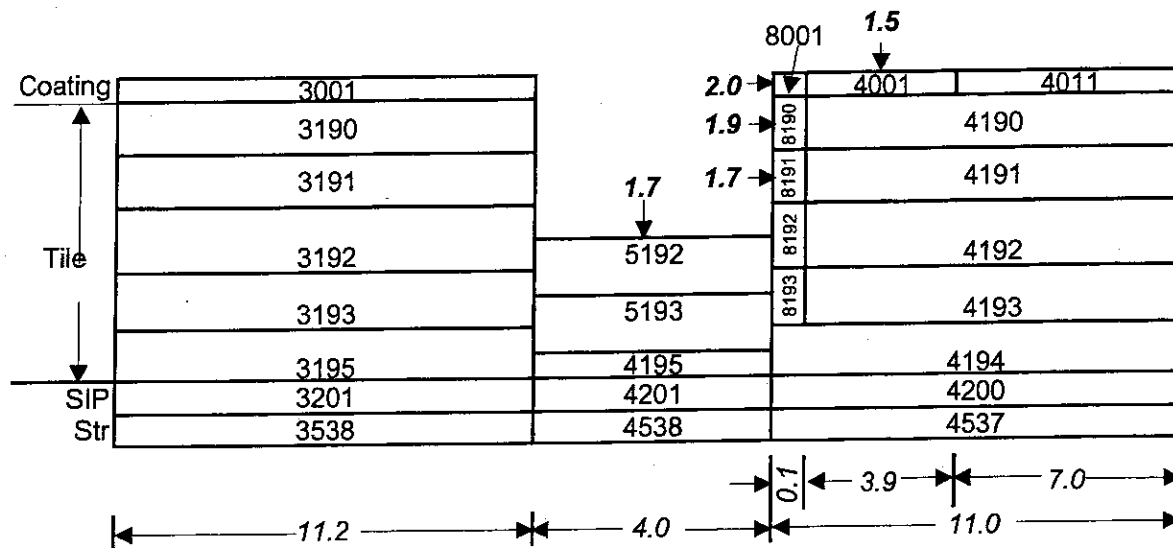
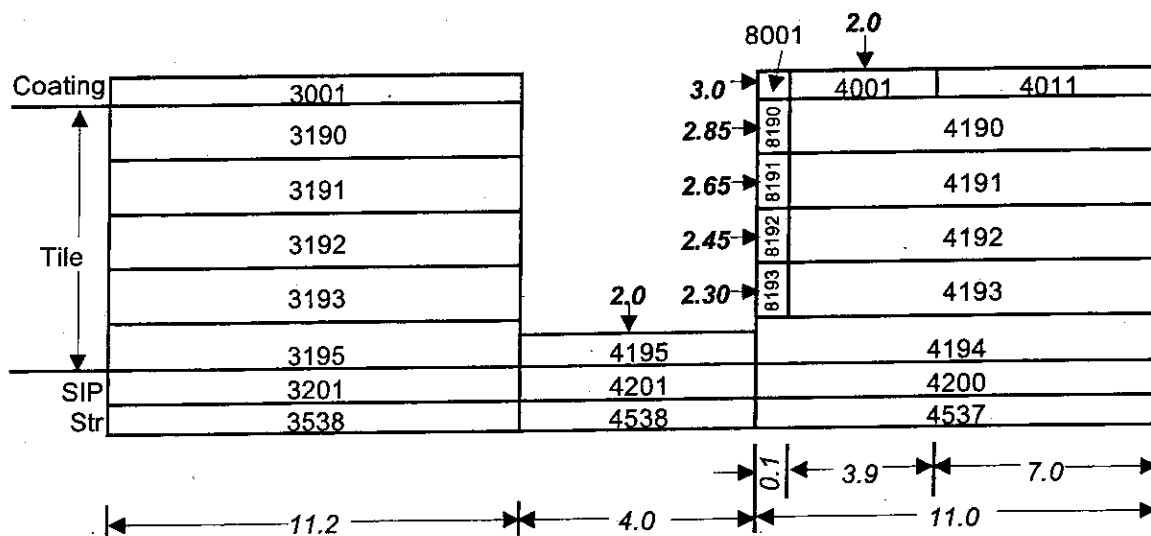
**Figure 6 - Cross Section Nodal Diagram of Hole Location 2 of TMM 352
(Heating Bump Factors in Bold Face Type)**

The location of the damage analyzed on OV-102 has a large frame attached to the underlying aluminum skin. This large mass distributed the heat well. However, there was no guarantee that damage would occur again at this benign location, and analysis of potential damage in this location would be unconservative. Therefore, a second hole location was chosen forward of the MLGD and away from the frame. The tile in this region is 1.15 inches. Two depths of this hole location were analyzed: one 4"x4"x0.5" (50% tile loss), and the other 4"x4"x1", leaving only the 0.15" densified layer of the tile. Heating factors were calculated for these two configurations (Figure 6), and both models were analyzed for the EOM and TAL trajectories.

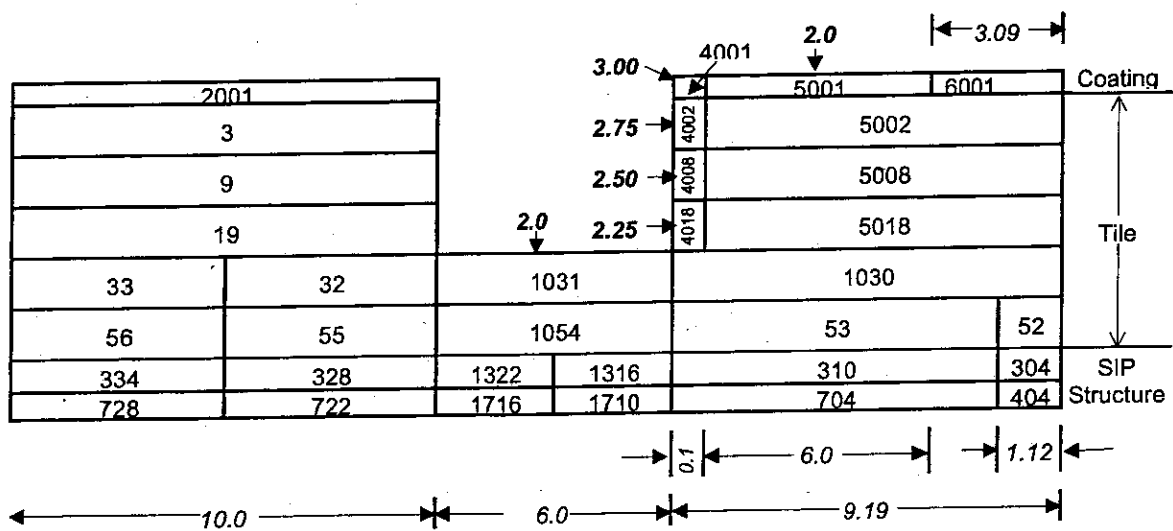
Figure 3 - Cross Section Nodal Diagram of TMM 99
(Heating Bump Factors in Bold Face Type)

To simulate the increased local heating due to the presence of the cavity, bump factors, provided by aeroheating, were imposed on the heating in and around the hole. Figure 3 shows the heating factors and where they were applied. The emissivity of the damaged tile surfaces was reduced to 0.5 due to the lack of black coating. Bottom sun entry interface (EI) temperatures were used for a worst case analysis.

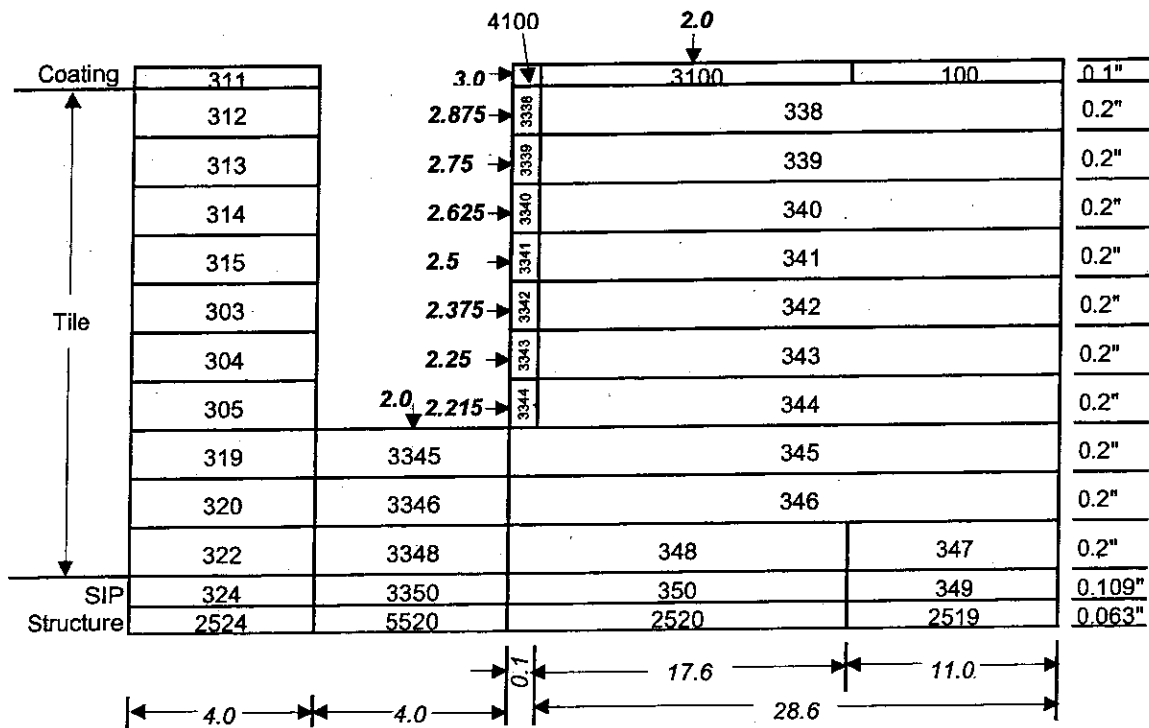
Figure 5 - Cross Section Nodal Diagram of Hole Location 1 of TMM 352
(Heating Bump Factors in Bold Face Type)

The model was renodalized in a similar manner to the TMM 99 modification. Heating bump factors were generated for this configuration as shown in Figure 5. The 0.5 emissivity for broken tile and the bottom sun EI temperatures were also used for this analysis.

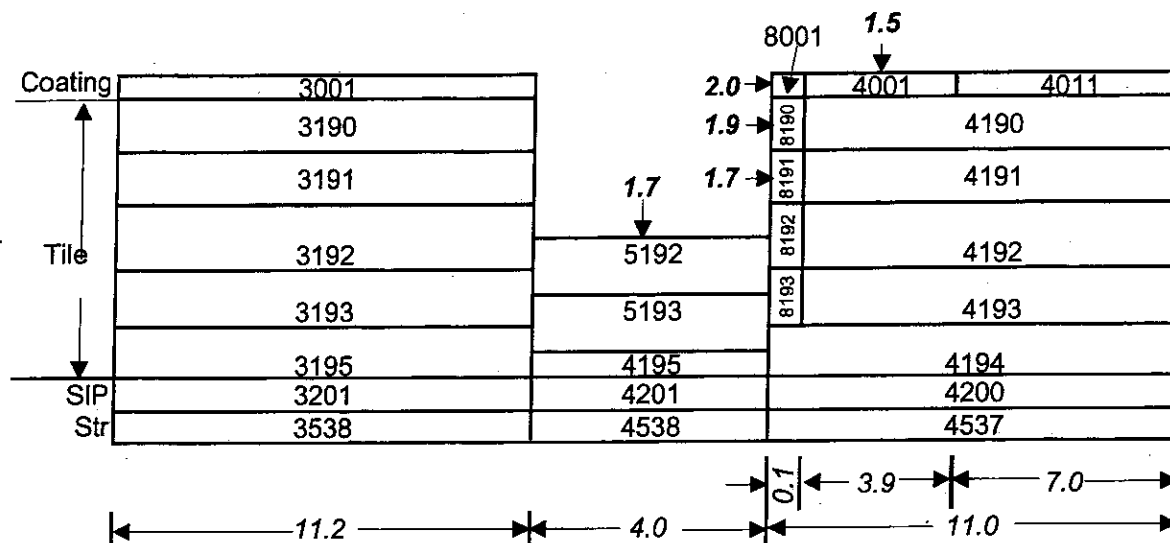
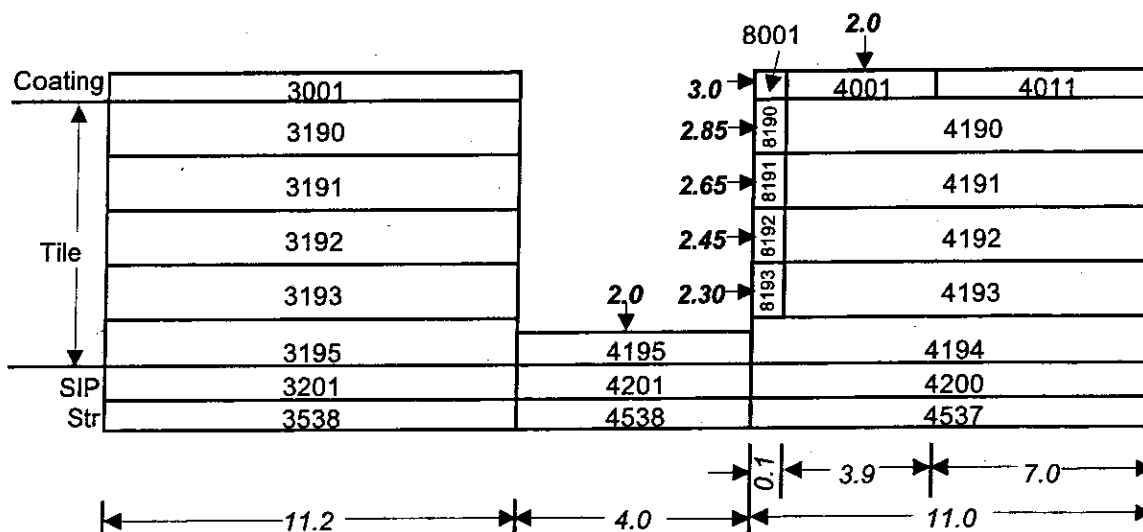
Figure 6 - Cross Section Nodal Diagram of Hole Location 2 of TMM 352
(Heating Bump Factors in Bold Face Type)

The location of the damage analyzed on OV-102 has a large frame attached to the underlying aluminum skin. This large mass distributed the heat well. However, there was no guarantee that damage would occur again at this benign location, and analysis of potential damage in this location would be unconservative. Therefore, a second hole location was chosen forward of the MLGD and away from the frame. The tile in this region is 1.15 inches. Two depths of this hole location were analyzed: one 4"x4"x0.5" (50% tile loss), and the other 4"x4"x1", leaving only the 0.15" densified layer of the tile. Heating factors were calculated for these two configurations (Figure 6), and both models were analyzed for the EOM and TAL trajectories.

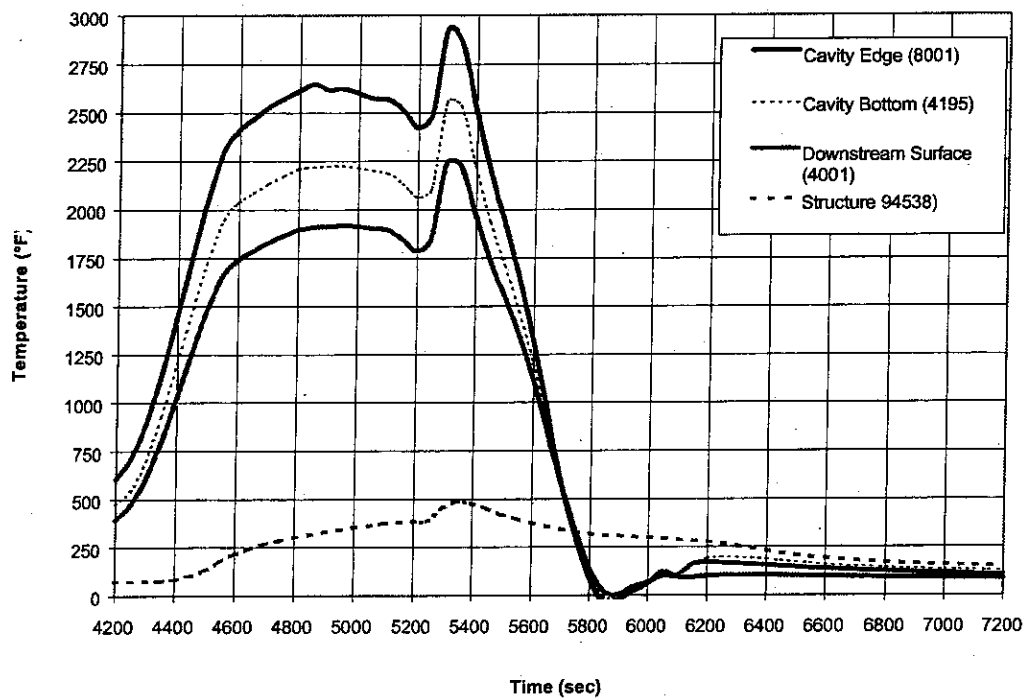
Figure 9 - STS-87 Temperature Results for TMM 352 Hole Location 1

The results of the evaluations are presented in Table 1 and Figure 8 through Figure 20. The STS-87 analysis resulted in TPS surface temperatures at the damage sites just above the melting point of the material. The local structure temperature results were all below material limits.
